Beede Waste Oil Superfund Site

Agenda

05/09/2022

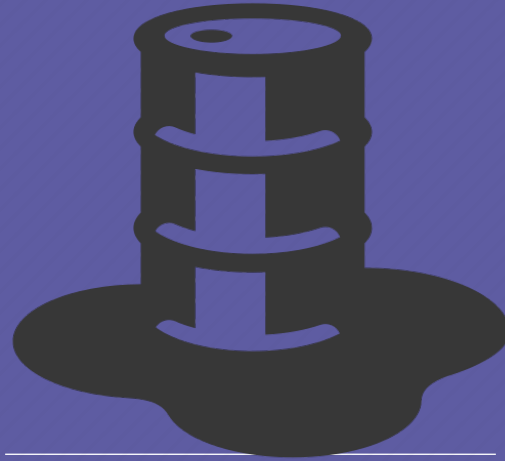
Treatment of deeper soils
and removal of landfill
debris impacted by
releases of oil, petroleum
and solvents within the
former lagoon, tank
storage and landfill areas

Thermal (Steam) Remediation of deeper soils to desorb and mobilize residual oils and contaminants from soil for recovery and treatment

✓ Phase 1 Lagoon Area completed in 2015

✓ Phase 2 Storage tanks area completed in 2020

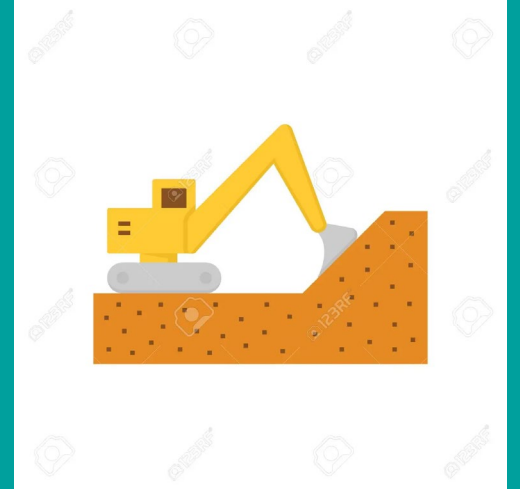
Excavation of
contaminated shallow
(up to ten feet) soils
primarily within parcel
1, removal of soil piles
and debris, backfilling,
grading and restoration

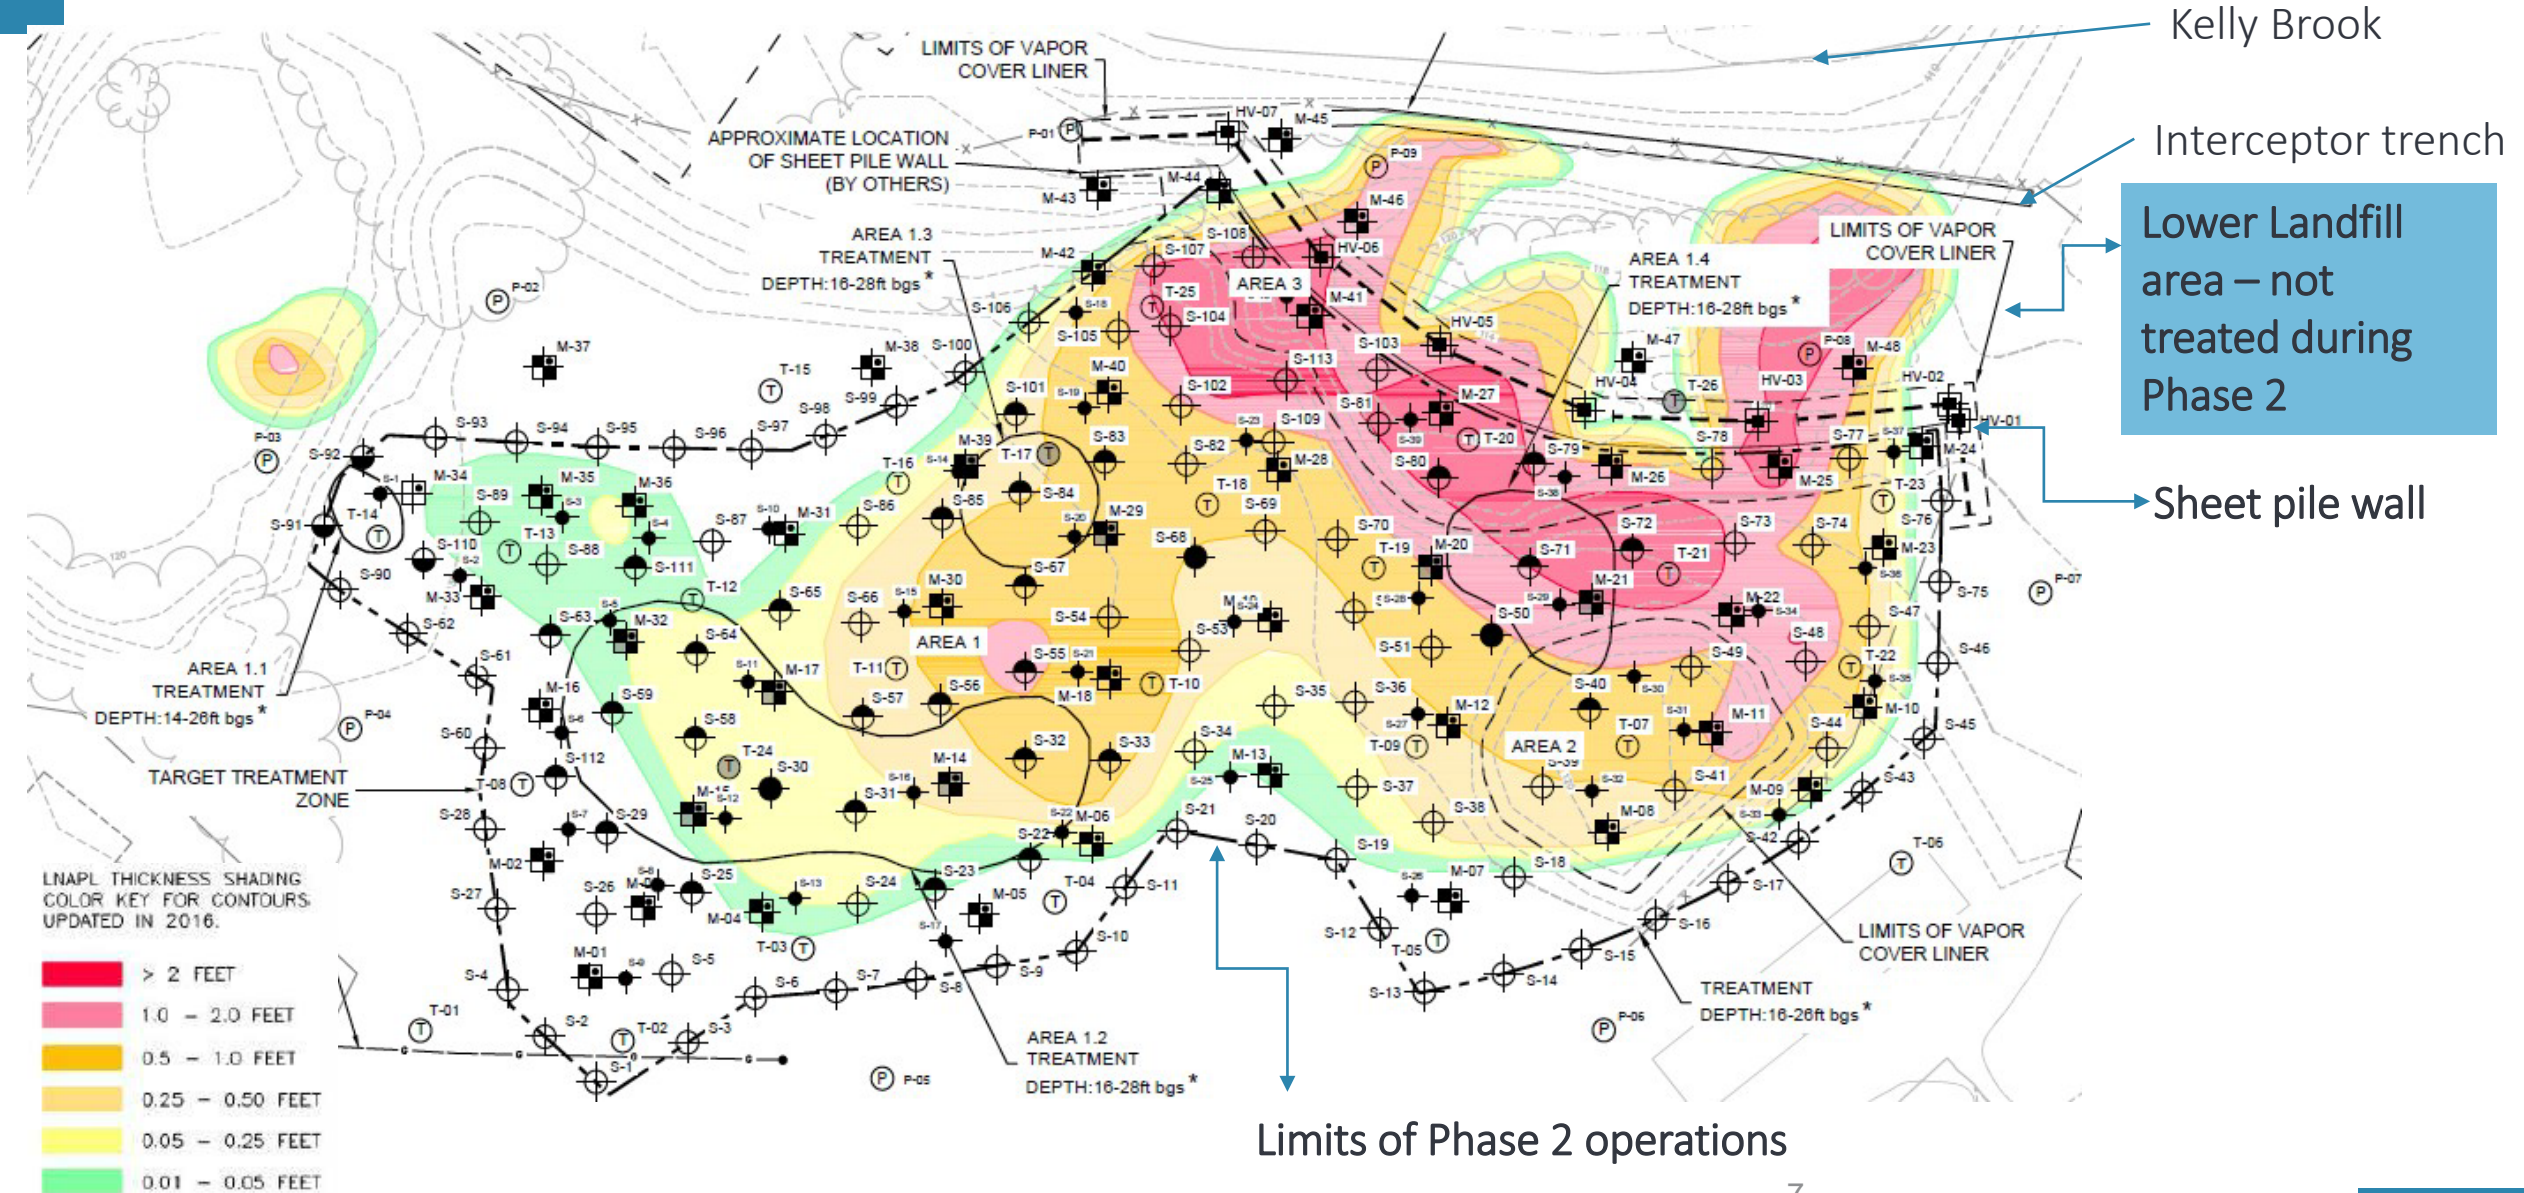
LNAPL (oil) – before Phase 2 Remediation

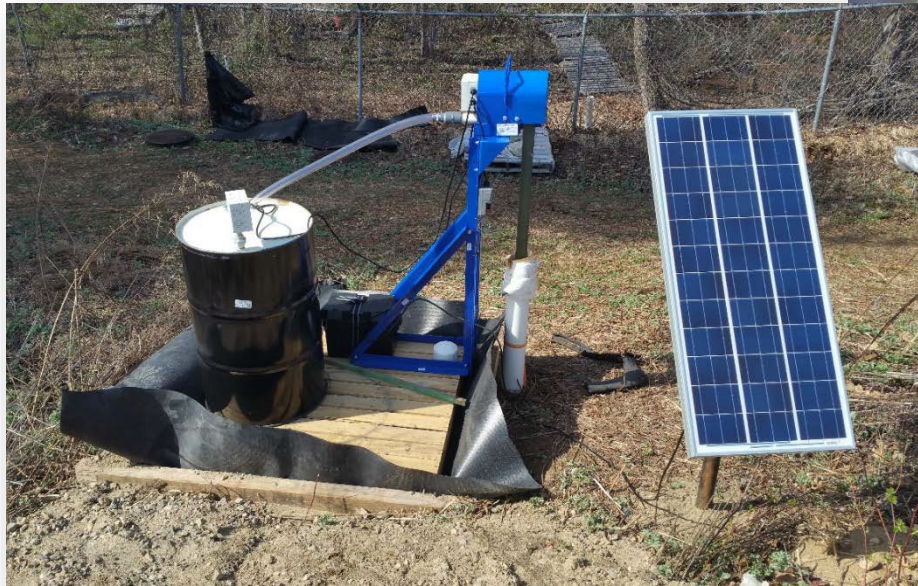
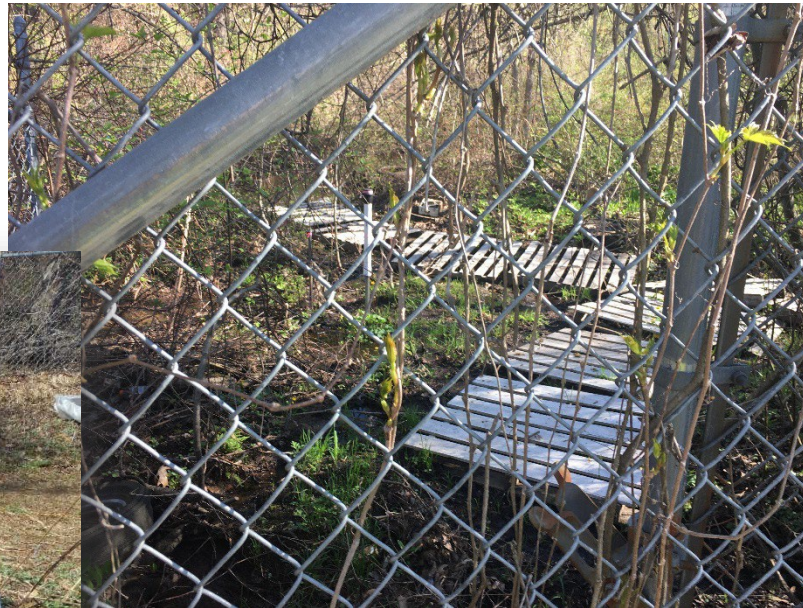
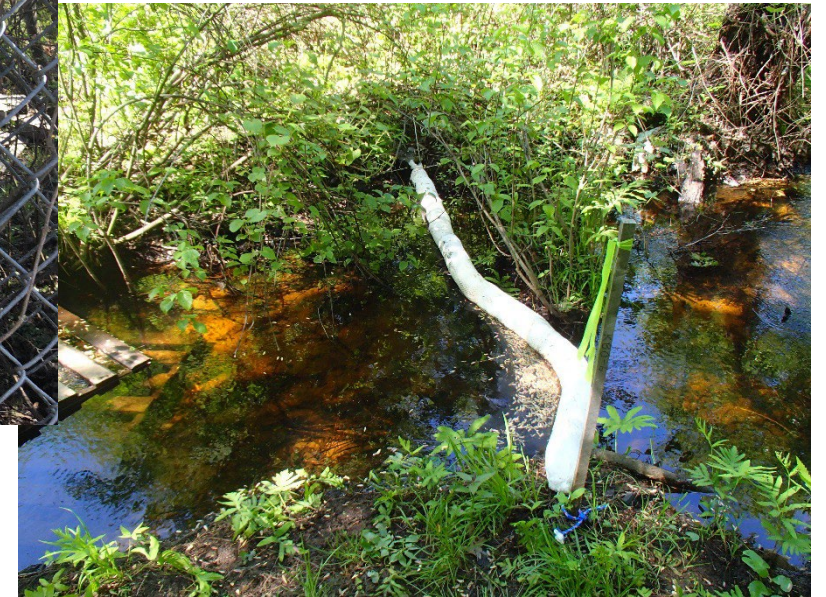
Phase 2 LNAPL recovery

- LNAPL recovery was required from the area between the Phase 2 treatment zone and the Kelley Brook interceptor trench through Multi phase contingency wells skimmers. This was done to minimize / prevent oil movement into Kelley Brook.
- Belt Skimmers have also been used in this area as well to recover oil.

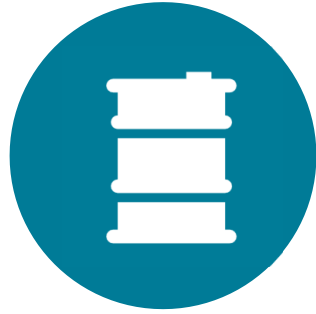
Focus on lower landfill and sediment area

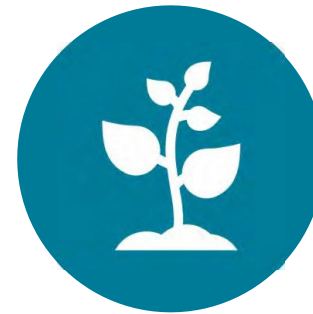
Soil and Debris Excavation

- Addressing residual oil impacts in soil
- Located between the Phase 2 thermal treatment area and Kelly Brook

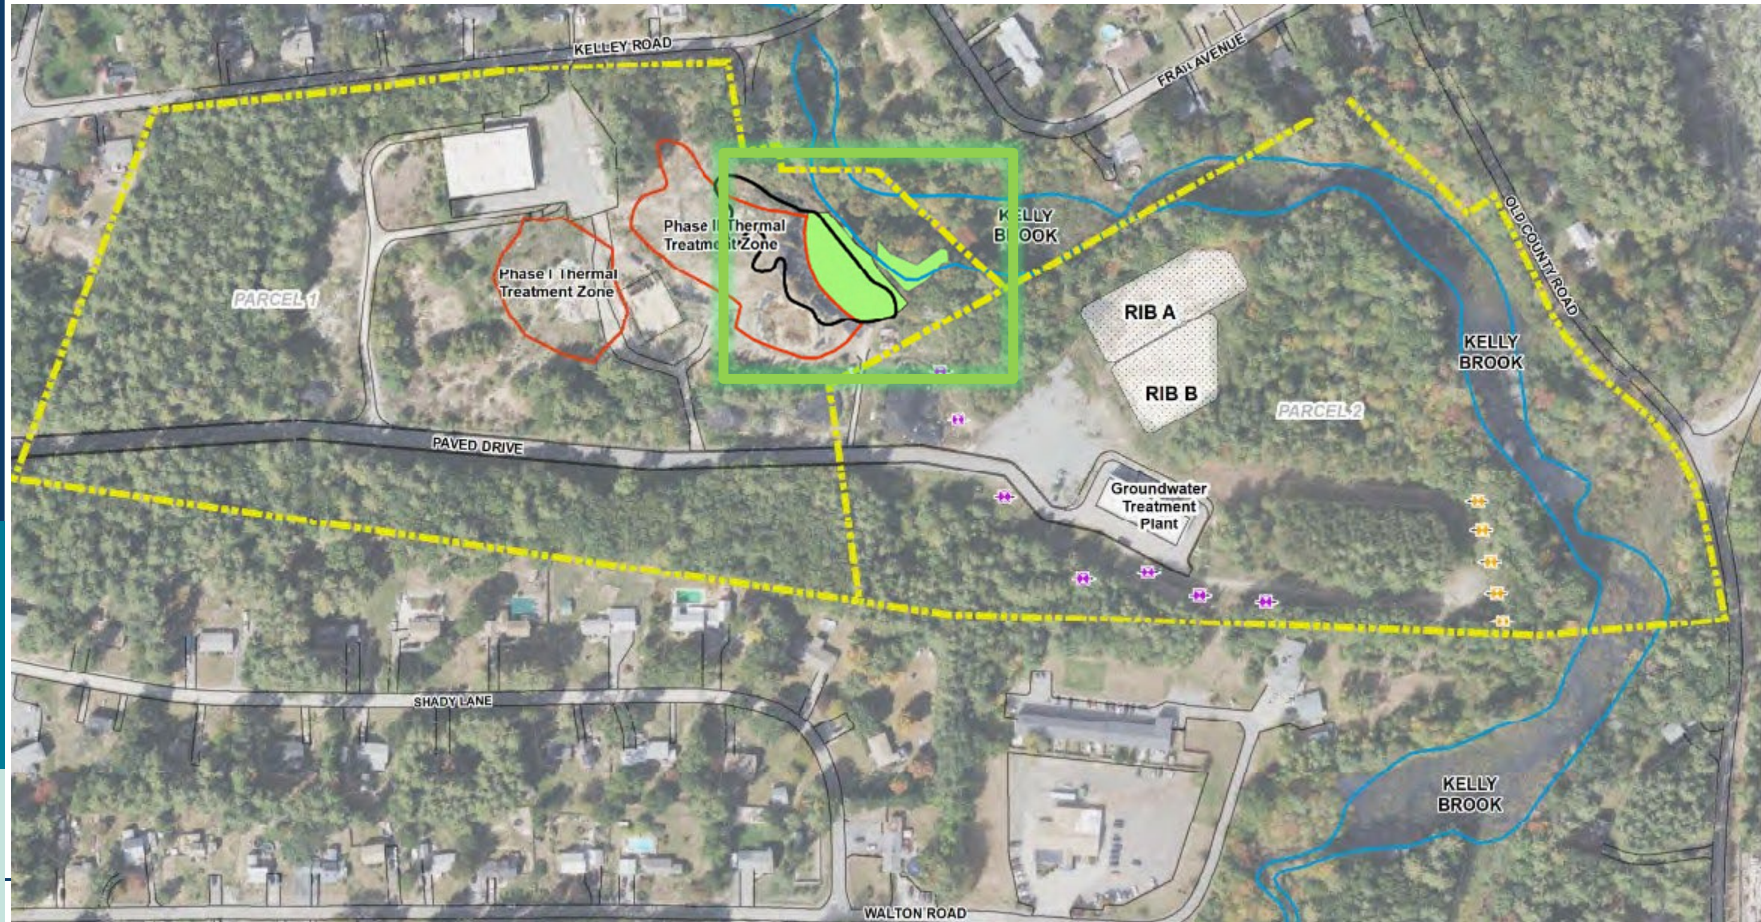
Where is this onsite?

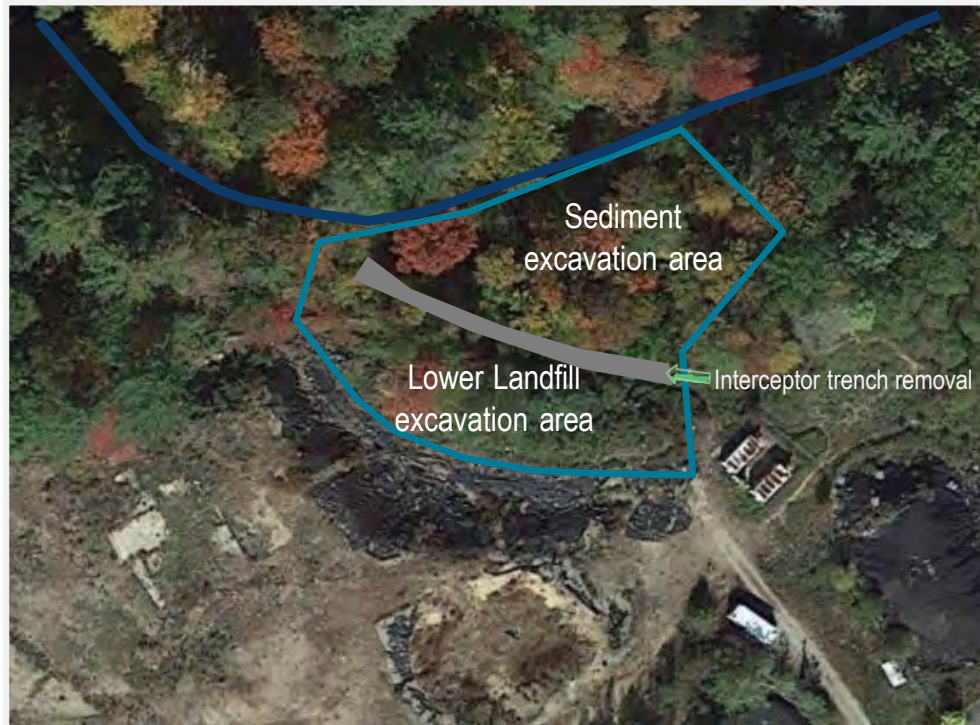
Estimated excavation volumes

Shallow soil and landfill debris ~
4,400 cubic yards (cy)

Smear zone soil (oil impacted) ~
1,700 cy

Interceptor trench concrete ~
70 cy

Sediment ~ 325 cy

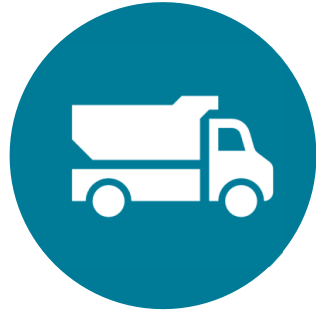
Onsite

- Sheet pile installation
- Excavation equipment (excavators, front end loaders, dump trucks)
- Removal of debris in Kelly Brook
