Municipal Energy Audit

December 15 2018

Plaistow Historical Society

127 Main Street

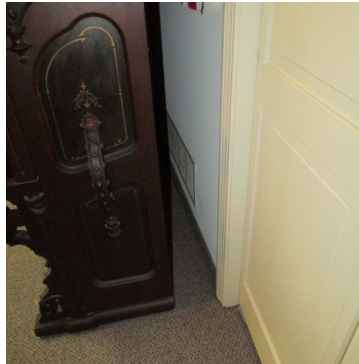
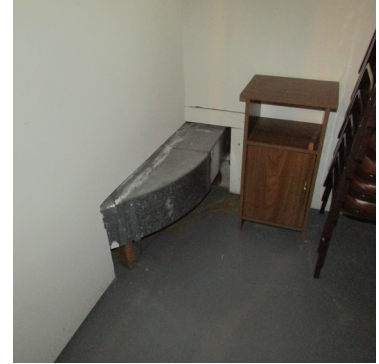
Distribution Issues

Air flow is inhibited by piano and quite possibly to inadequate return ducts.

- It appears that the Return register is partially blocked by the piano, (photos on page 5) thereby limiting air flow back to the furnace. It also appears that the size of the return duct is considerably smaller than the sum total of supply ducts. This also reduces the efficacy of distributing heat and—in addition to outside air infiltration—results in the upstairs being much warmer than downstairs.

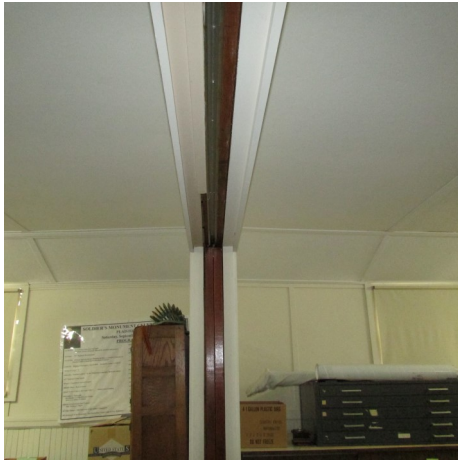
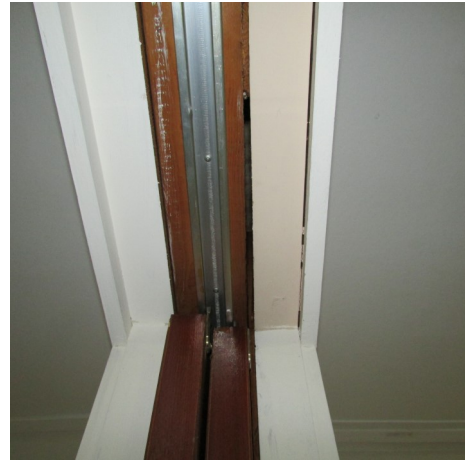
Staining—especially along wood strips covering fiber board seams—indicating air leakage sites and likely condensation.

Tier One air sealing package addresses air sealing these seams from the attic with a skim coat of foam.

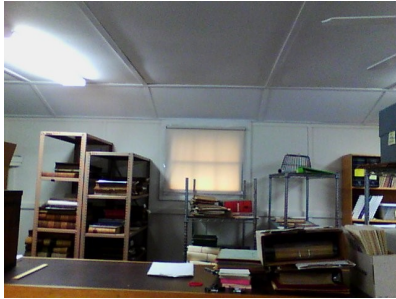
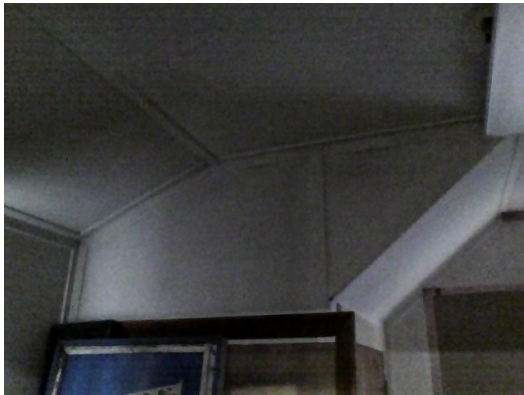
Thermal bypasses occur as cold air is allowed to move through low density insulation, such as fiberglass.

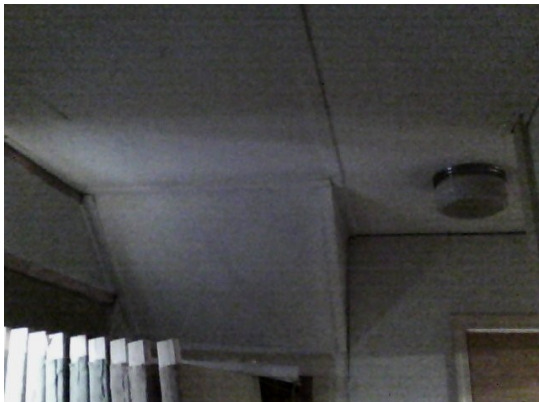
Envelope ESM's are designed to address these areas of coolth. Stains suggest water damage from backed up ice dams or where condensation formed.

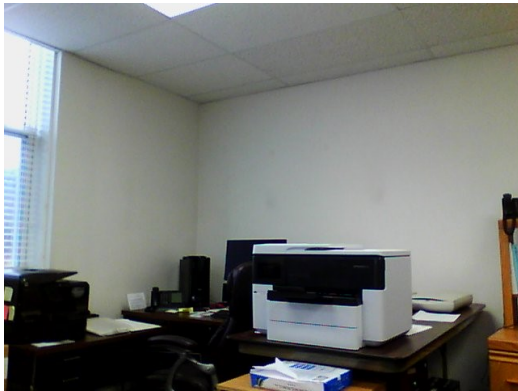
First floor office addition: appears to be 2x4 stick framed with fiberglass batts in the cavities. The southeast corner appears to have suffered water damage at some time.
